Objectid	Description	Image	Thumb
1,114,464	NULL	 	 
1,114,464	Cages were difficult to extract with a lot of corrosion	 	 
1,114,464	During rebuild by volunteer David Woolley

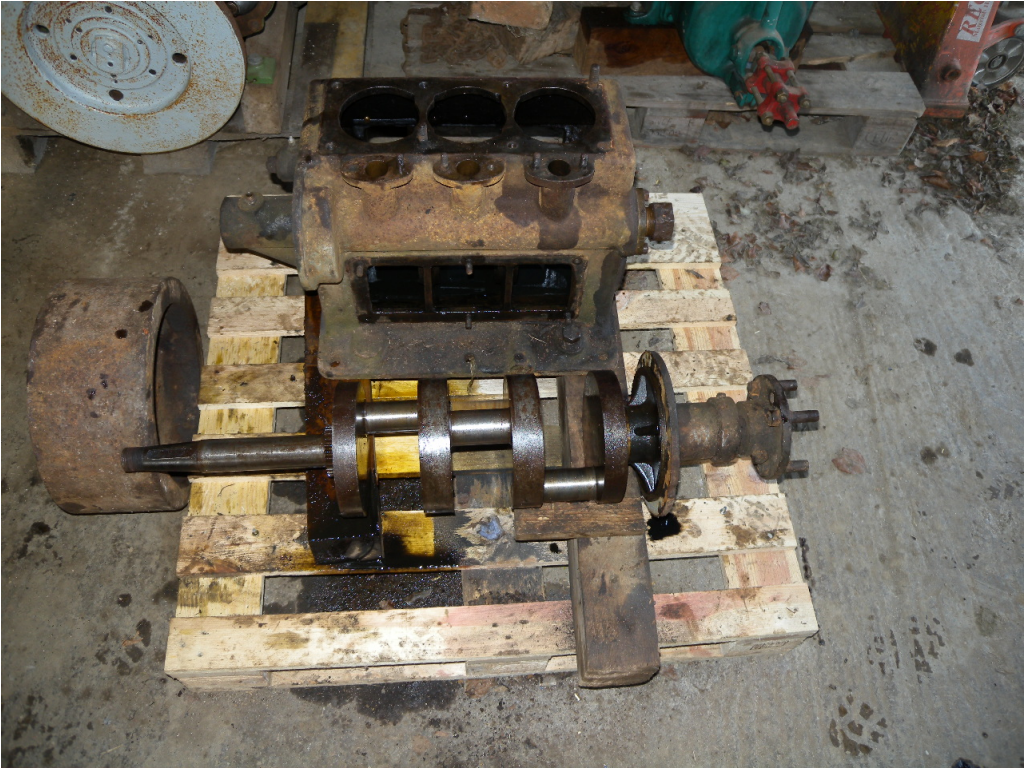
Objectid	Description	Image	Thumb
1,114,464	Journals in good condition

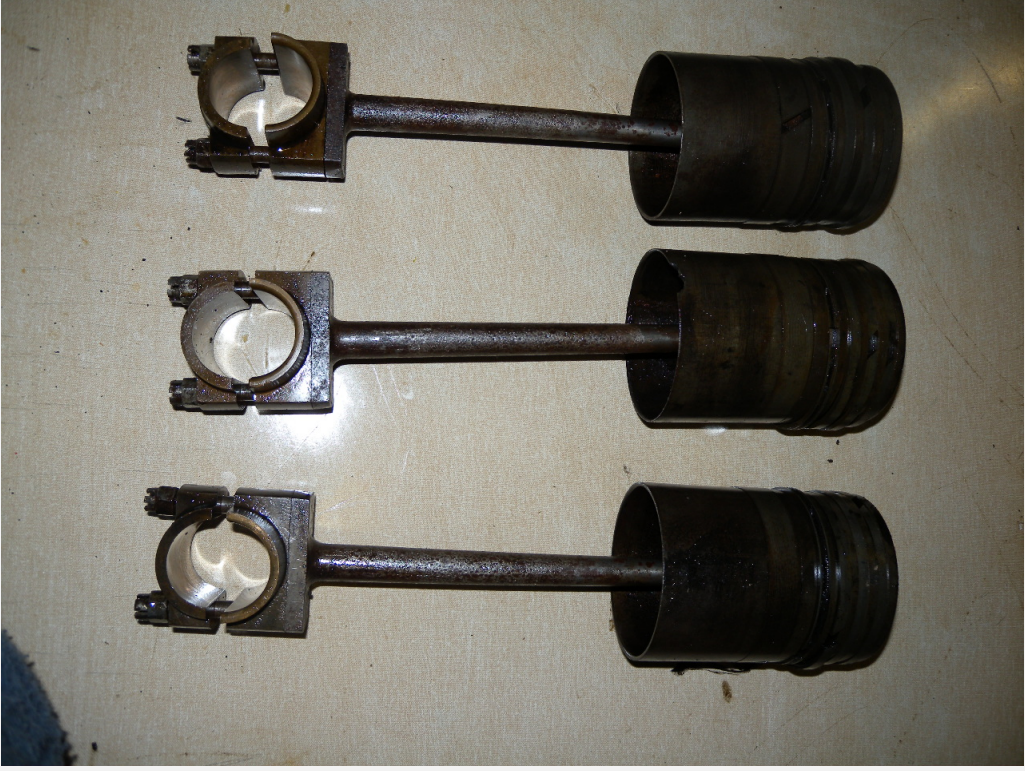
A small, square thumbnail image showing a close-up of the journals and surrounding engine parts.
1,114,464	Pistons in reasonable order with little wear
