Object:-	Ruston 6VE		
Object ID:-	1751	Accession No:-	IF:2007:6
Date:-	1930-06-30	Works Number:-	145430
Category:-	Engine		
Collection:-	Internal Fire Core Collection		
Manufacturer:-	Ruston and Hornsby Ltd		
Made In:-	Lincoln, England

6 cylinder four stroke diesel engine driving English Electric direct coupled generator. Originally supplied to the BBC as part of four sets for the Moorside Edge Transmitting Station near Huddersfield. Develops 300hp at 330rpm.

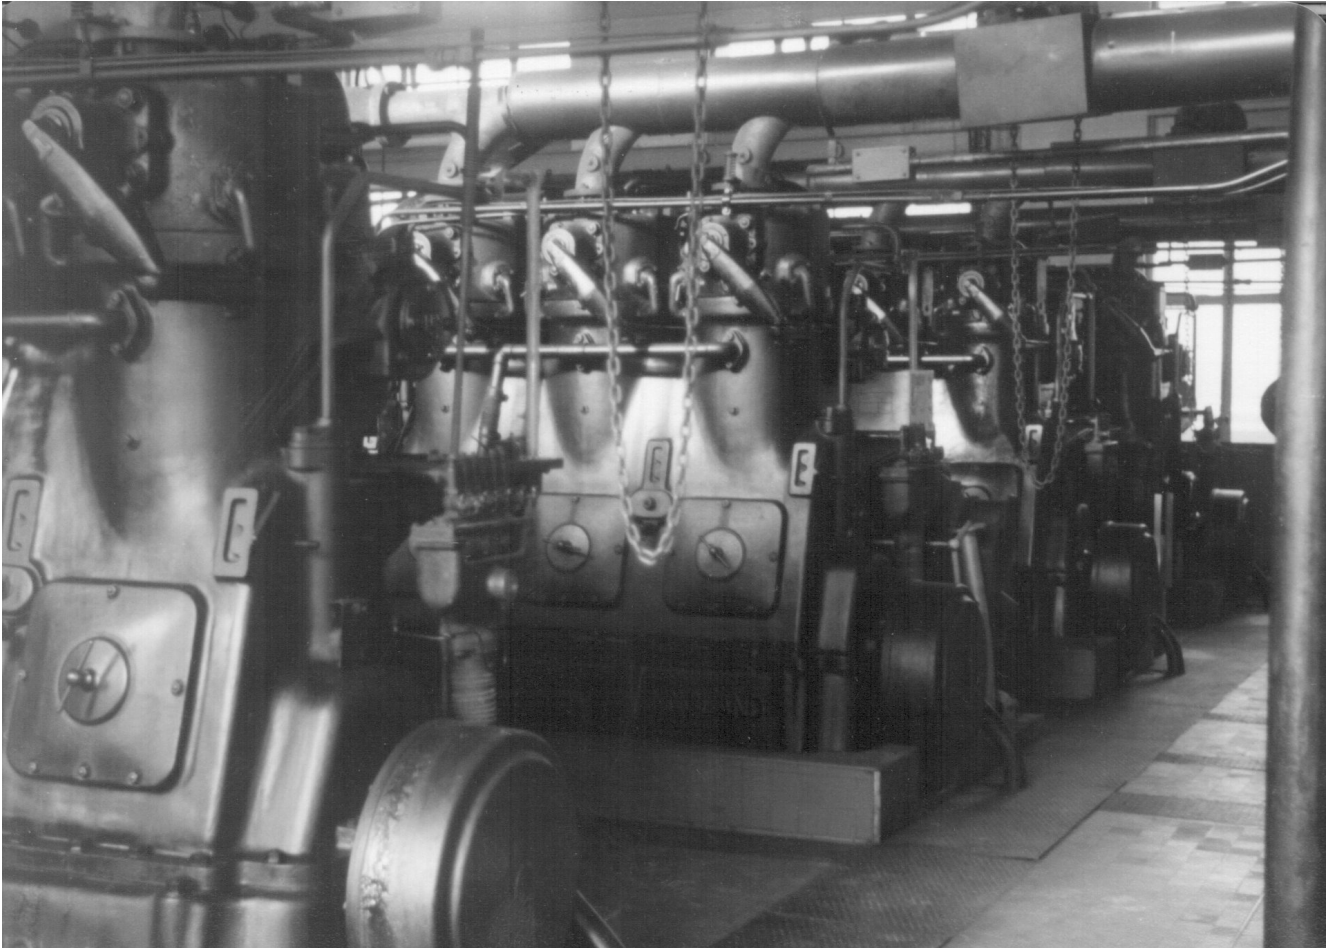
Fuel pump removed to solve leaking element on 4,5,6.
