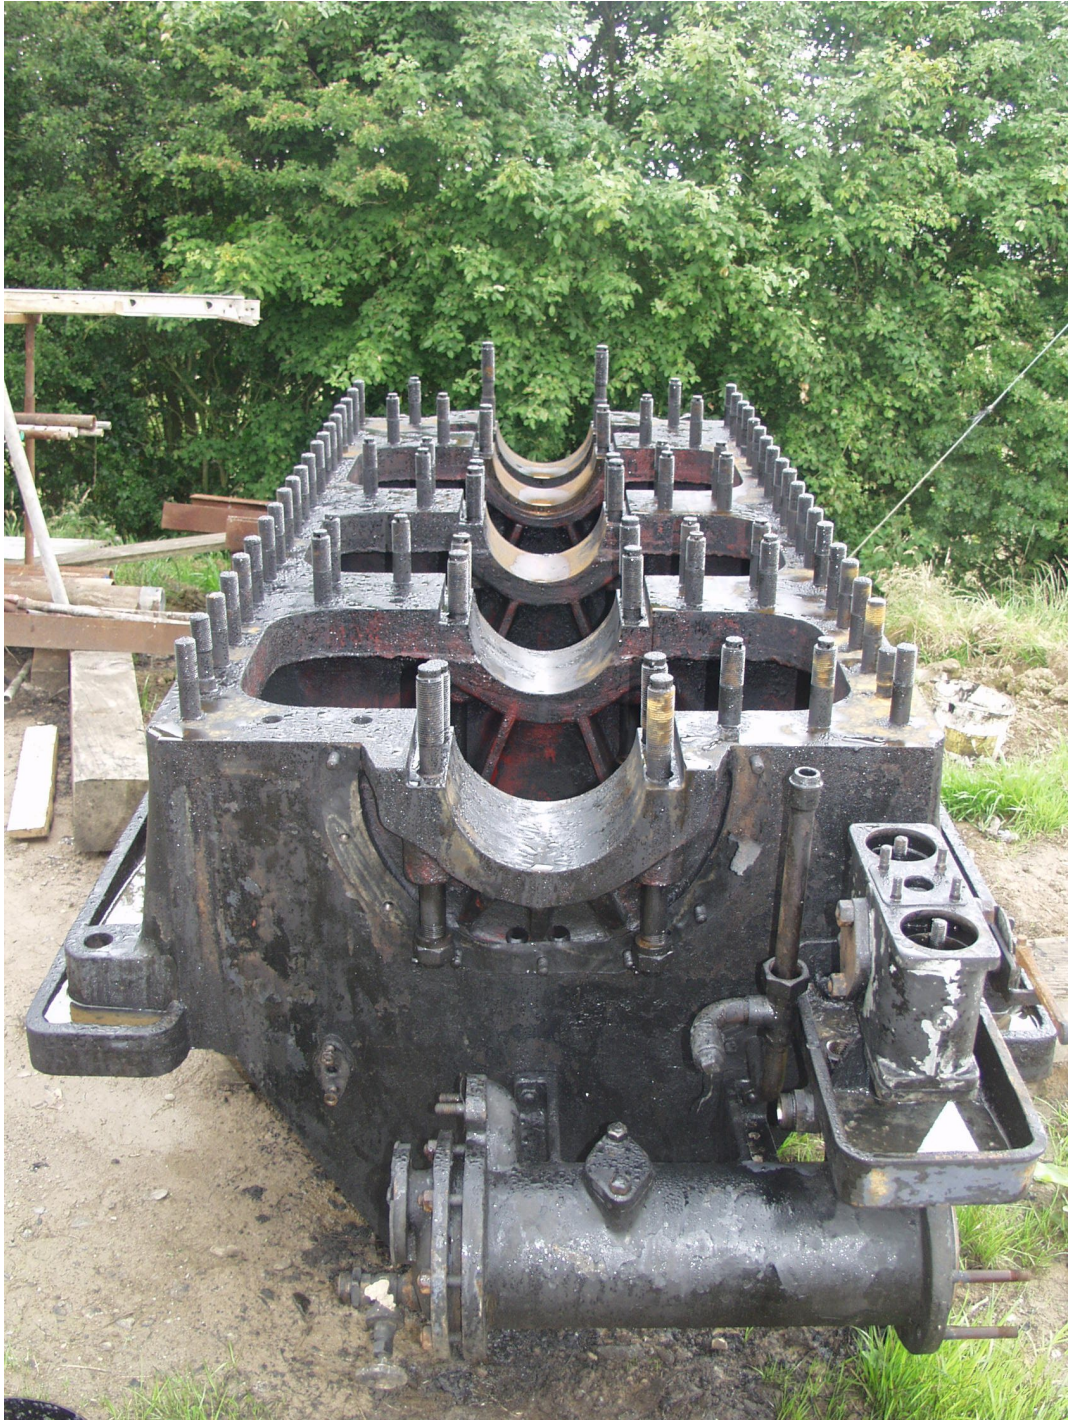
Objectid	Description	Image	Thumb
1,625	Stripped for rebuild - July 2008

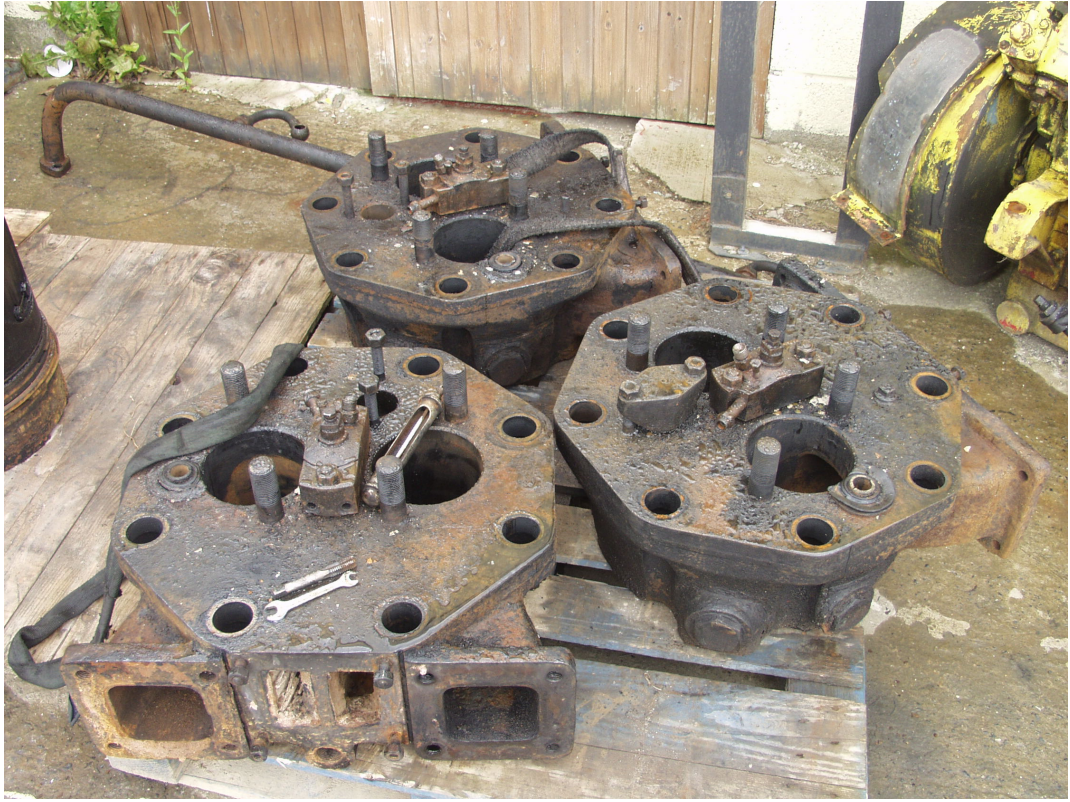
Objectid	Description	Image	Thumb
1,625	Stripped for rebuild, heads - July 2008
