<b>Object:-</b>	<b>Allen 8S30</b>
-----------------	-------------------

<b>Object ID:-</b>	793	<b>Accession No:-</b>	IF:2005:002
<b>Date:-</b>	1941-03-04	<b>Works Number:-</b>	K2/46406/B
<b>Category:-</b>	Engine		
<b>Collection:-</b>	W.H. Allen Heritage		
<b>Manufacturer:-</b>	W. H. Allen Sons and Co. Ltd		
<b>Made In:-</b>	Queens Engineering Works, Bedford, UK

<b>Description:-</b>
Straight 8 skid mount genset with Mather & Platt alternator and exciter. Isenthal regulator. 355BHP at 600 rpm. Stroke 300mm, Bore 230mm

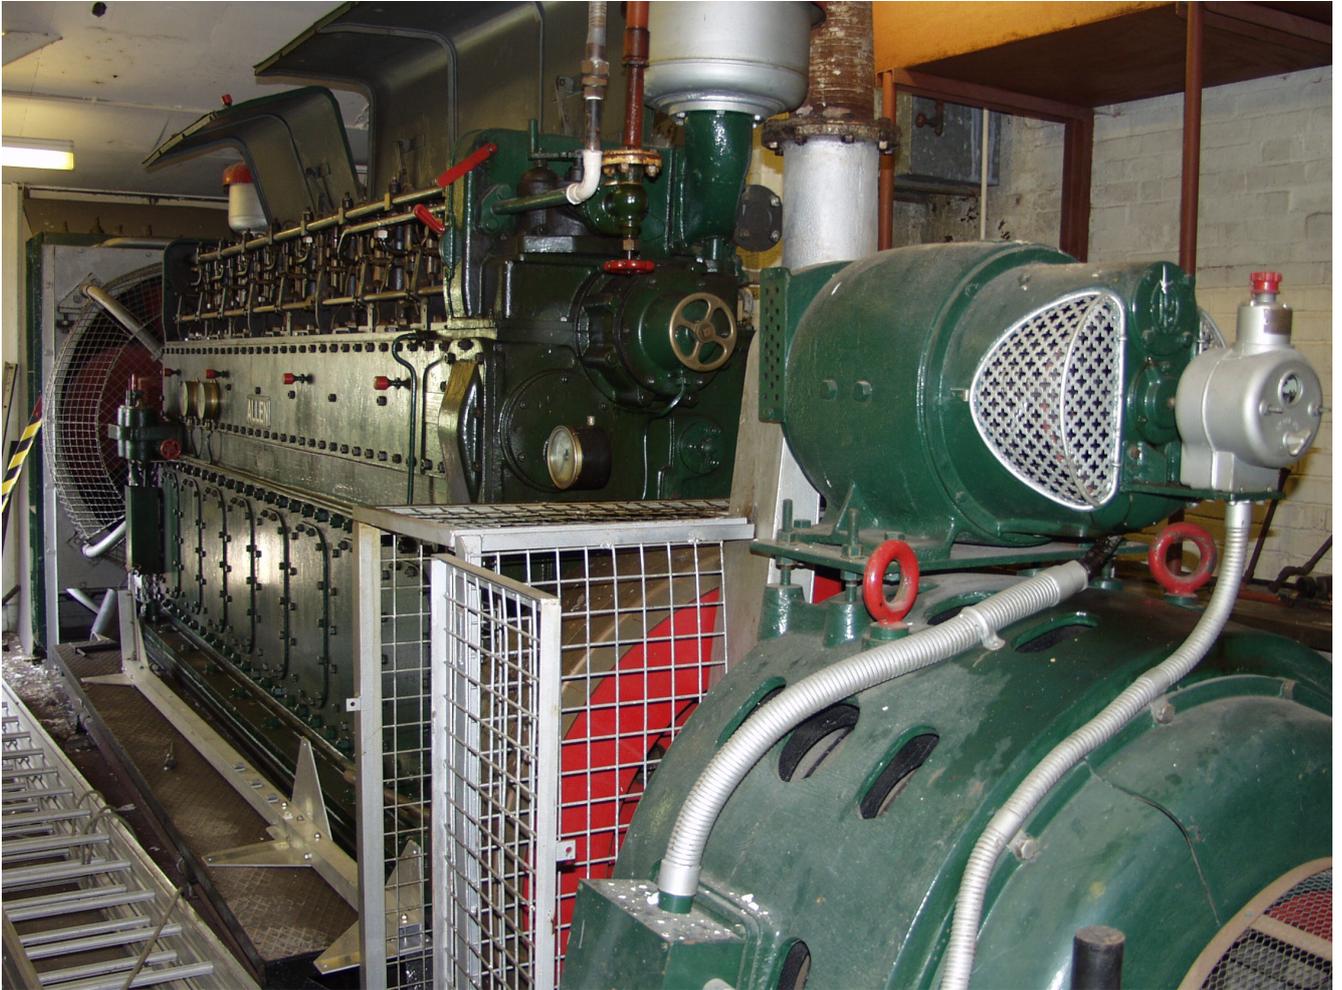
Number 3 piston removed and found to be unserviceable along with the liner.

On arrival we were aware of damage to cylinder No 3. This required a complete liner and piston change along with the big end. These parts were sourced from the ex Flexsys twin cylinder Allen, IFOD ID 1628
